Advanced methane drainage strategy-technology employing underground directional drilling technology for major risk prevention and greenhouse gases emission mitigation

Deformation analysis in the surroundings of the roadway ahead of longwall mining, Staszic-Wujek Mine, Poland

Petr Waclawik, Radovan Kukutsch, Kristyna Schuchova , Jan Nemcik, Andrzej Walentek, Aleksander Wrana, Sahendra Ram, Jiri Korbel

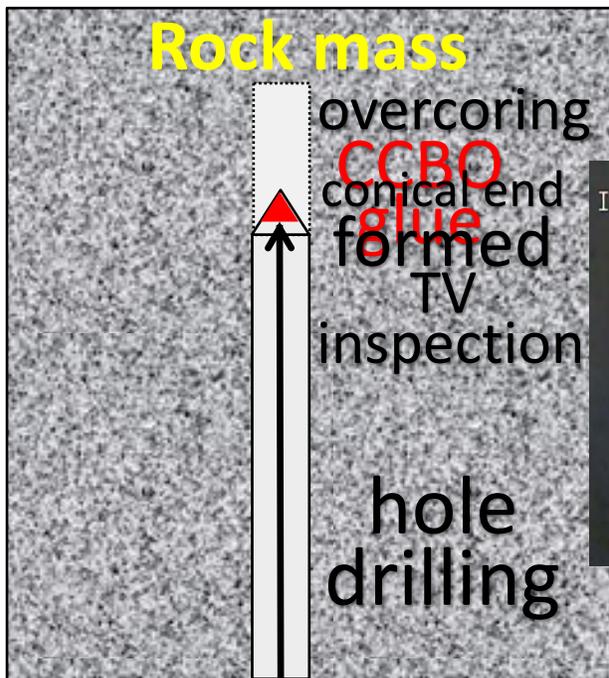
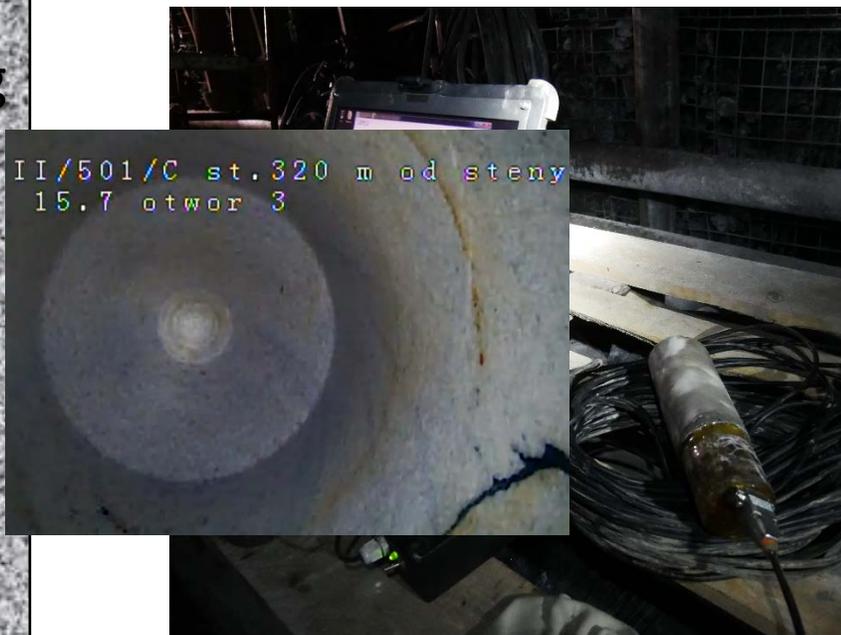
Transmission data to computer

CCBO probe (Compact Conical ended Borehole Overcoring) installation

Measurement (investigation) of the rock stress is usually carried out by interpretation of the rock mass deformation processes. To measure initial in situ stress in RM, the **Compact Conical ended Borehole Overcoring** (CCBO) method was used. To measure stress changes in the state of stress in the RM, the **Compact Conical ended Borehole Monitoring method** (CCBM) was used.

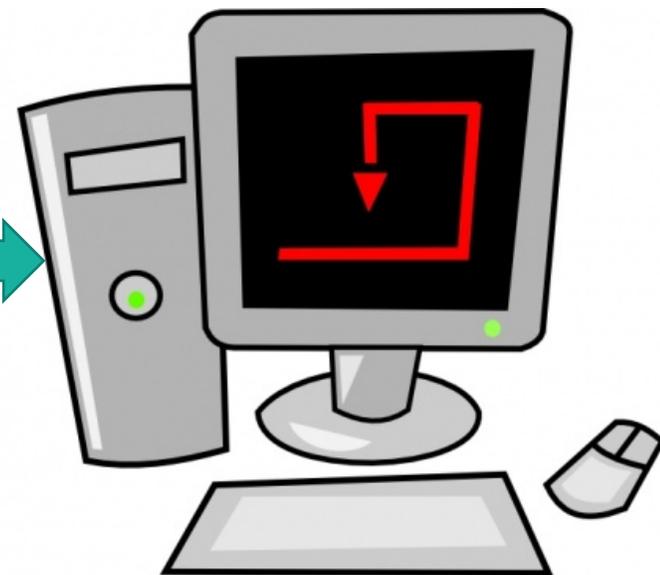
Calculation of initial stress in Sigma software

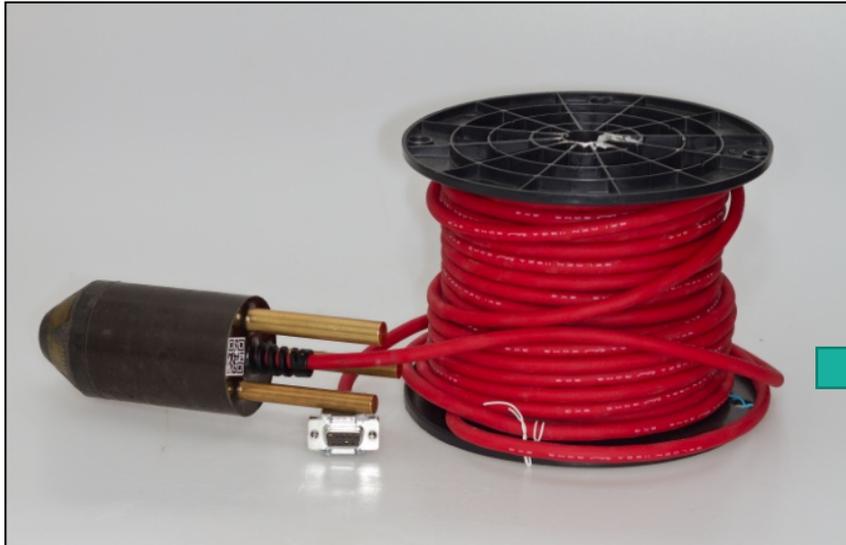
CCBM (Compact Conical Borehole Monitoring) probe installation with same principles as CCBO probe without overcoring process

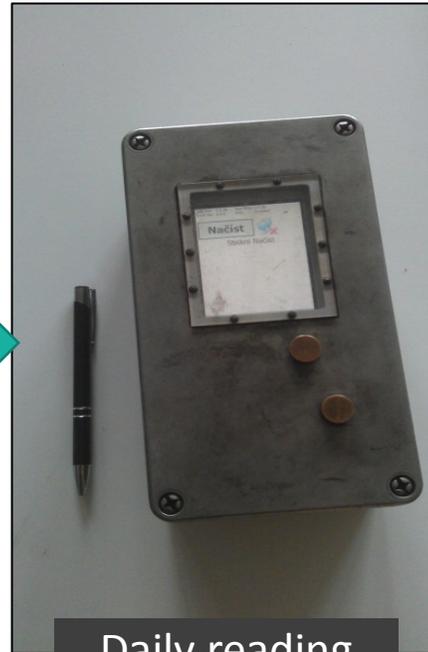
Daily reading by handheld computer

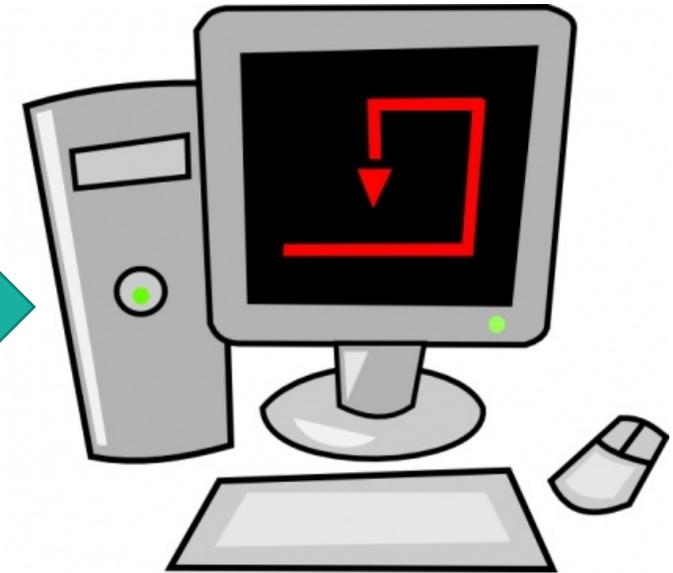
Data evaluation in Sigma software

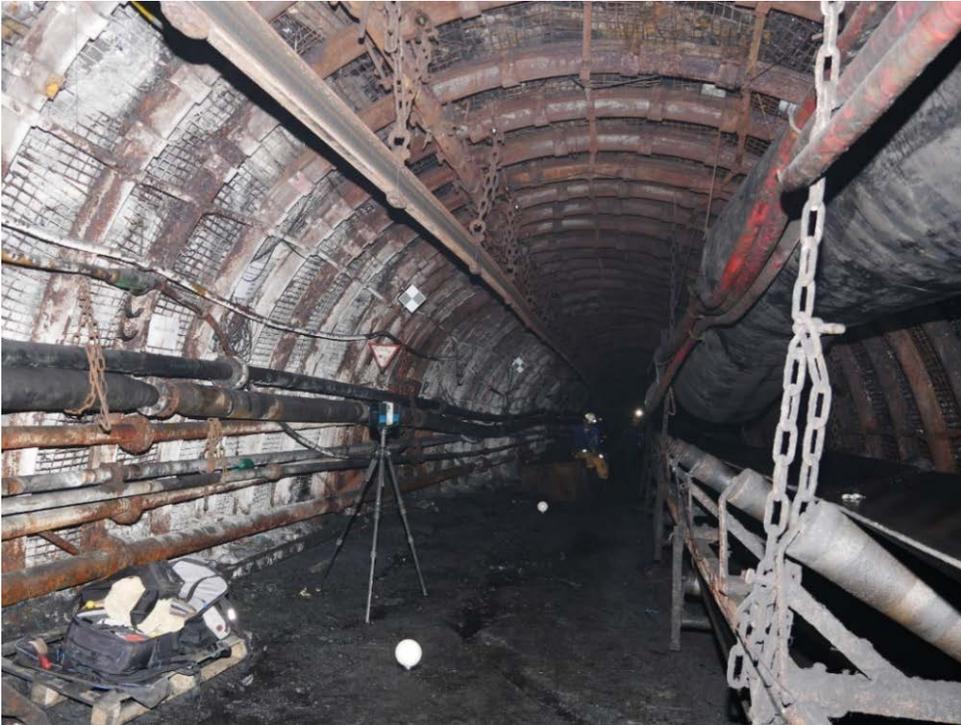
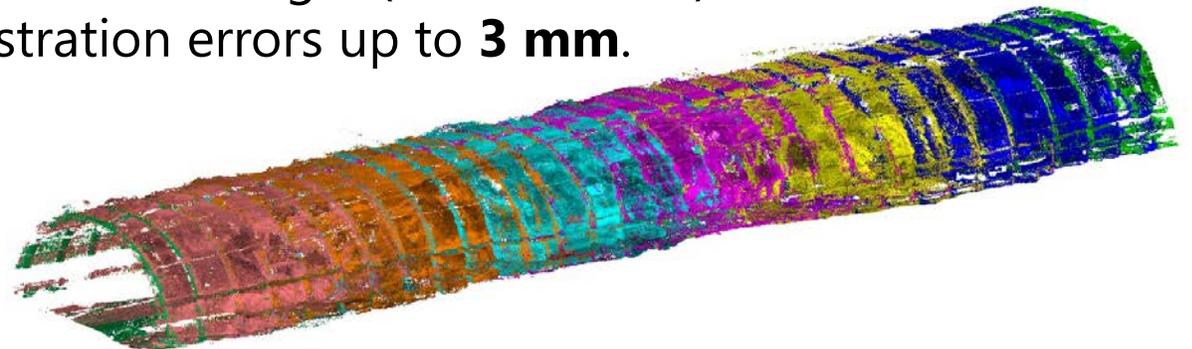
- The **Faro Focus S 350** scanner was used as part of scanning the roadways.
- Monitoring of deformation changes in front of the advancing longwall, within a distance of ± 20 m in each direction from the geotechnical station.
- Initial scans after the installation of the geotechnical station x scanning of the geotechnical station at four distances in front.
- The step between the positions was set at **5 m**.
- Reference spheres with a diameter of 140 mm and checkerboard target (200x200 mm) were used.
- Registration errors up to **3 mm**.

The deformation analysis of roadway at the monitoring station was carried out using a pulse **3D laser scanner**. The purpose was to capture deformation changes ahead of the advancing longwall face; specifically, at five stages in the ± 20 m section on each side from the station.

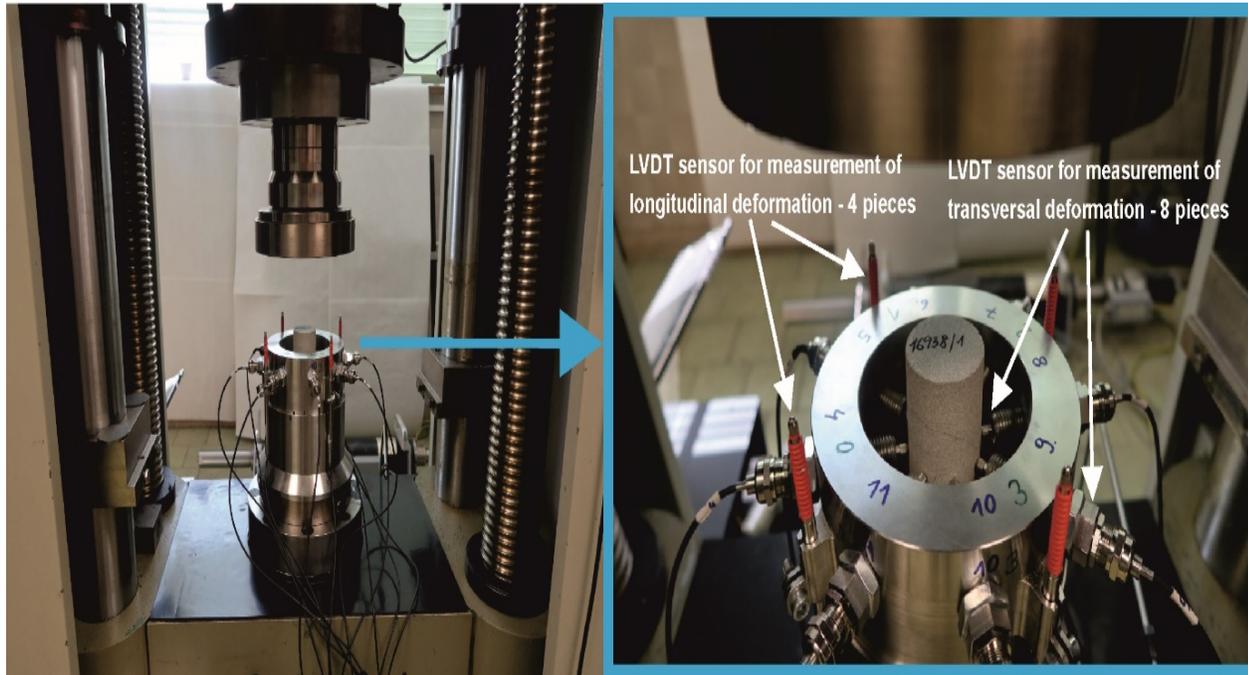
- The compressive strengths and deformation properties of rocks were tested using the **ZWICK 1494** mechanical press machine with the special load cell using the LVDT (Linear Variable Displacement Transformer) sensor).
- The bulk density ρ_0 , the uniaxial compressive strength (**UCS**) σ_D , Young's modulus **E**, and Poisson's ratio μ were defined from core samples.

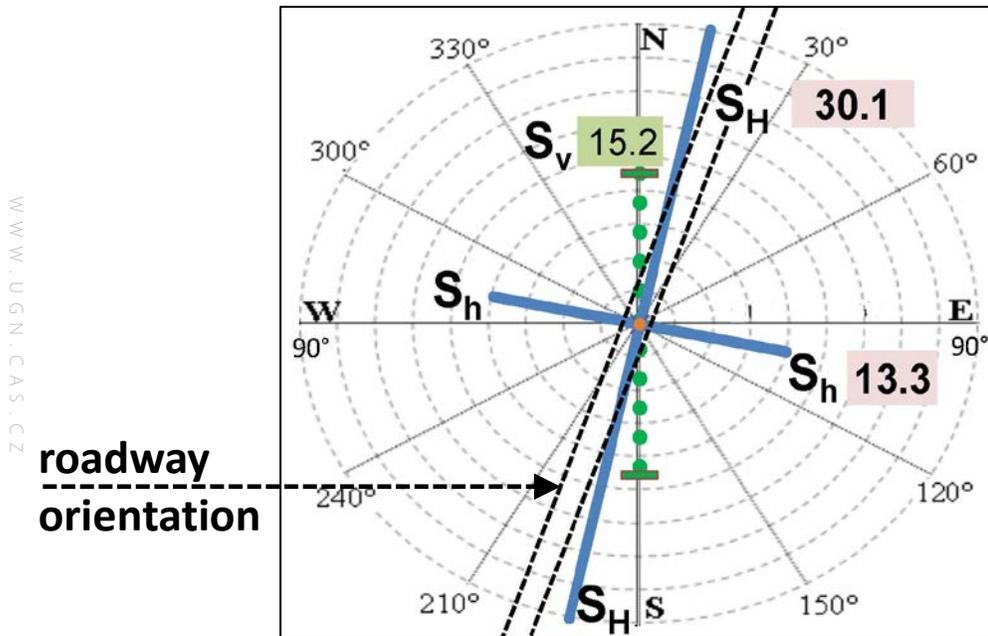
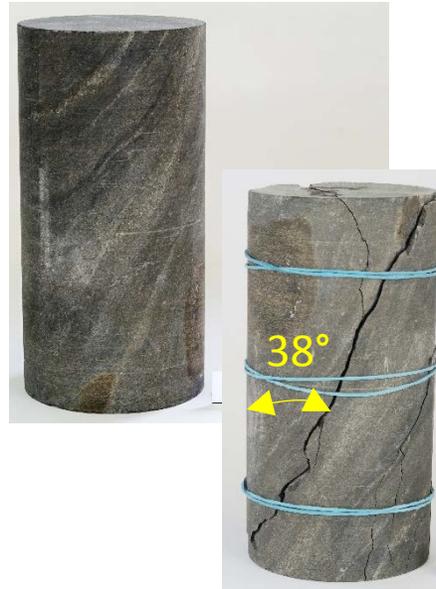
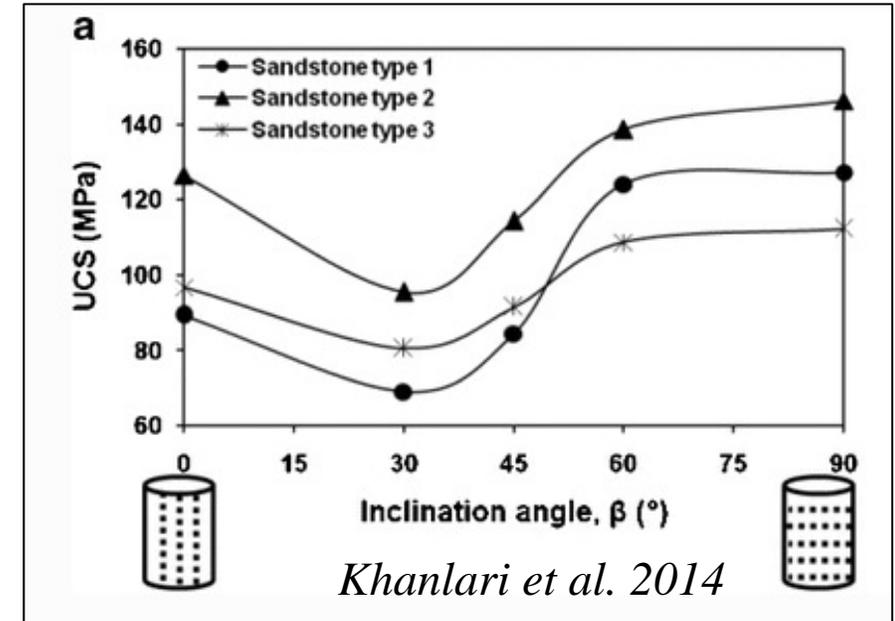
overcoring core

- Theoretical value of the vertical stress $\sim 21 \text{ MPa} \times S_v 15,2 \text{ MPa} \Rightarrow$ influence of the properties assessment - sedimentation foliation at inclination of 38° to the compression axis - 30% reduction in value.
- Maximal horizontal stress component (S_H) **twice** the vertical stress (S_v).
- The orientation of the maximum horizontal stress is **almost identical** to the orientation of the roadway.

- The maximum horizontal stress component S_H is approximately **2 times** higher than the observed vertical stress S_v . The previously observed trend that the maximum stress value is caused in the almost horizontal plane was thus confirmed.

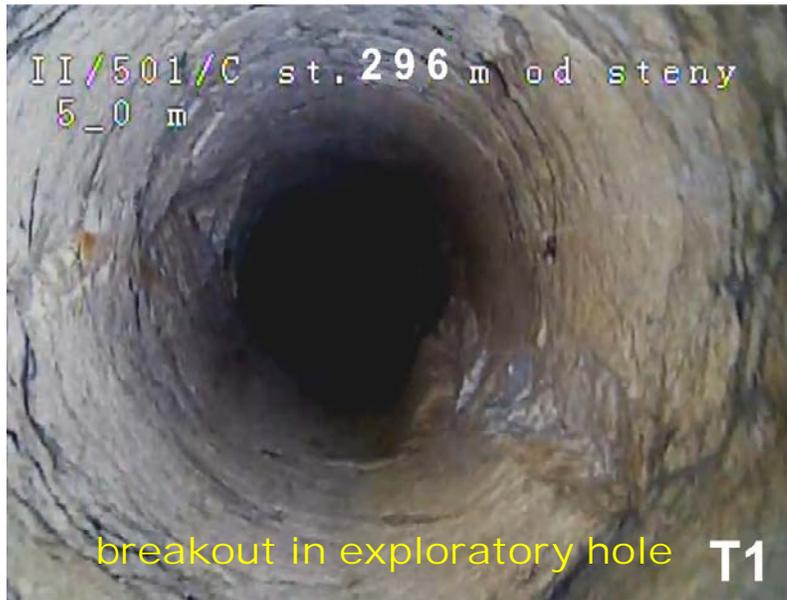
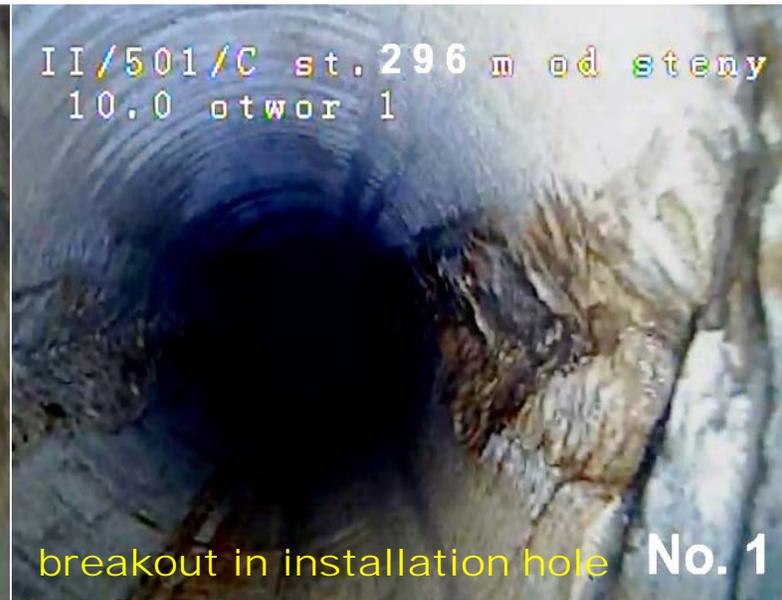
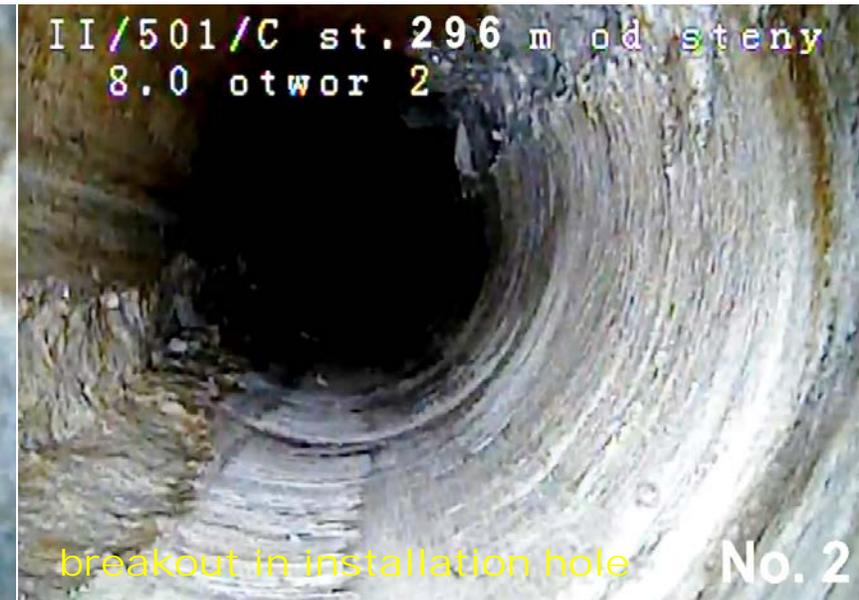
- The significance of the effect of the maximum horizontal stress component S_H was also confirmed by the observed **borehole breakout**.
- These borehole breakouts were recorded during the video inspection of exploratory borehole T1 and the installation boreholes No.1 and 2 at the monitored location.

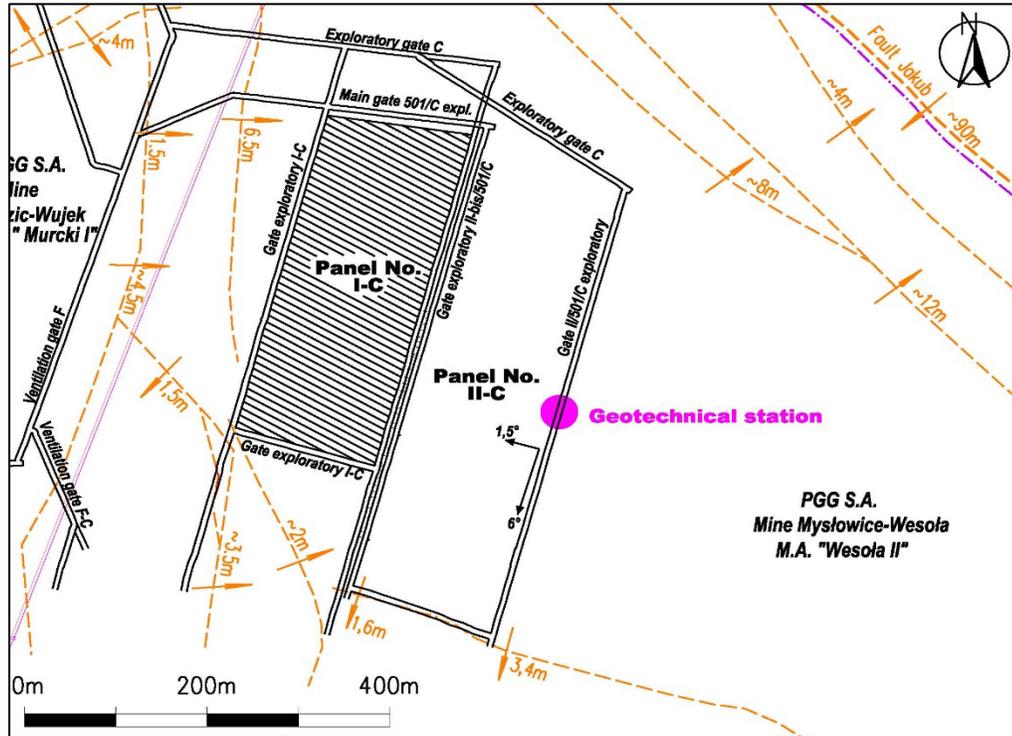
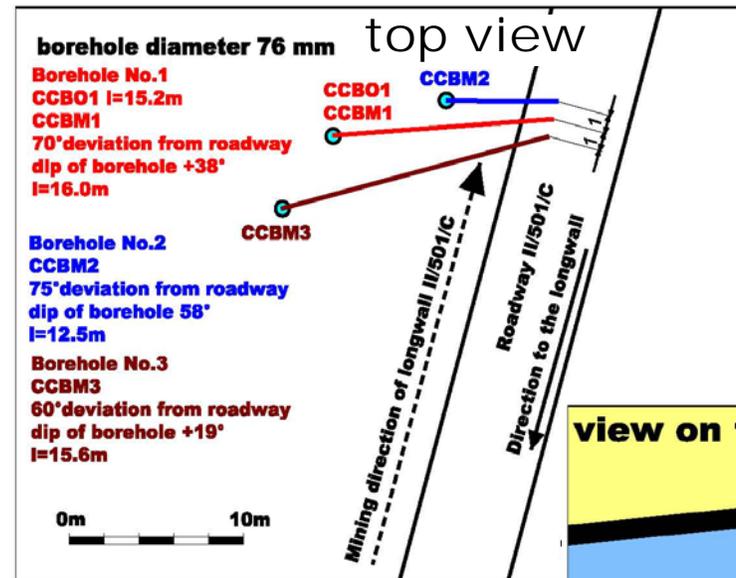
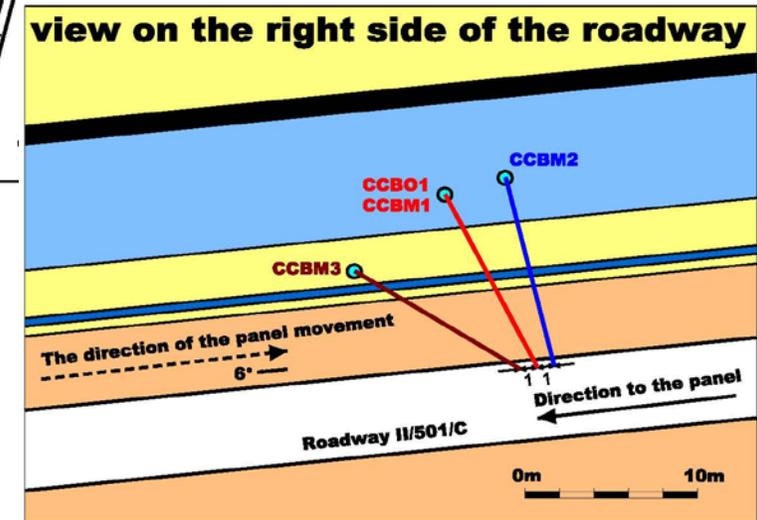
- Depth ~ **890 m** below the surface.
- Seam thickness ranges from **3.05** to **3.65 m**.
- The incline of the layers is approx. **7°** to the South-East.

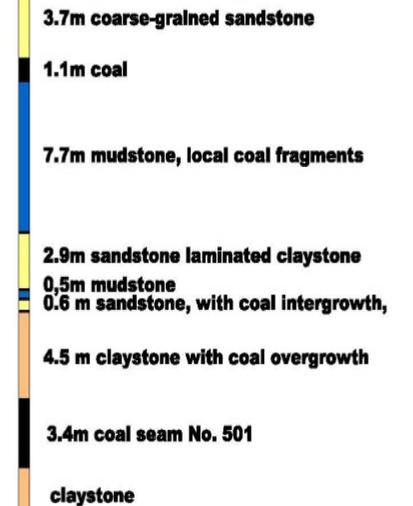
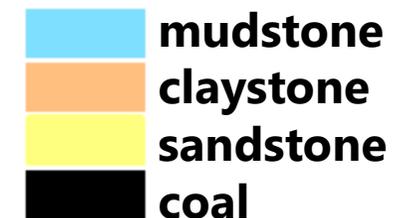
Exploratory borehole T1

- Distance of the geotechnical station from the longwall after installation 296 m.
- Average value of **RQD 65 -94 %** => rock quality category „fair“ to „excellent“.
- Average simple compression strength **53 MPa**; deformation modulus **23 GPa**.

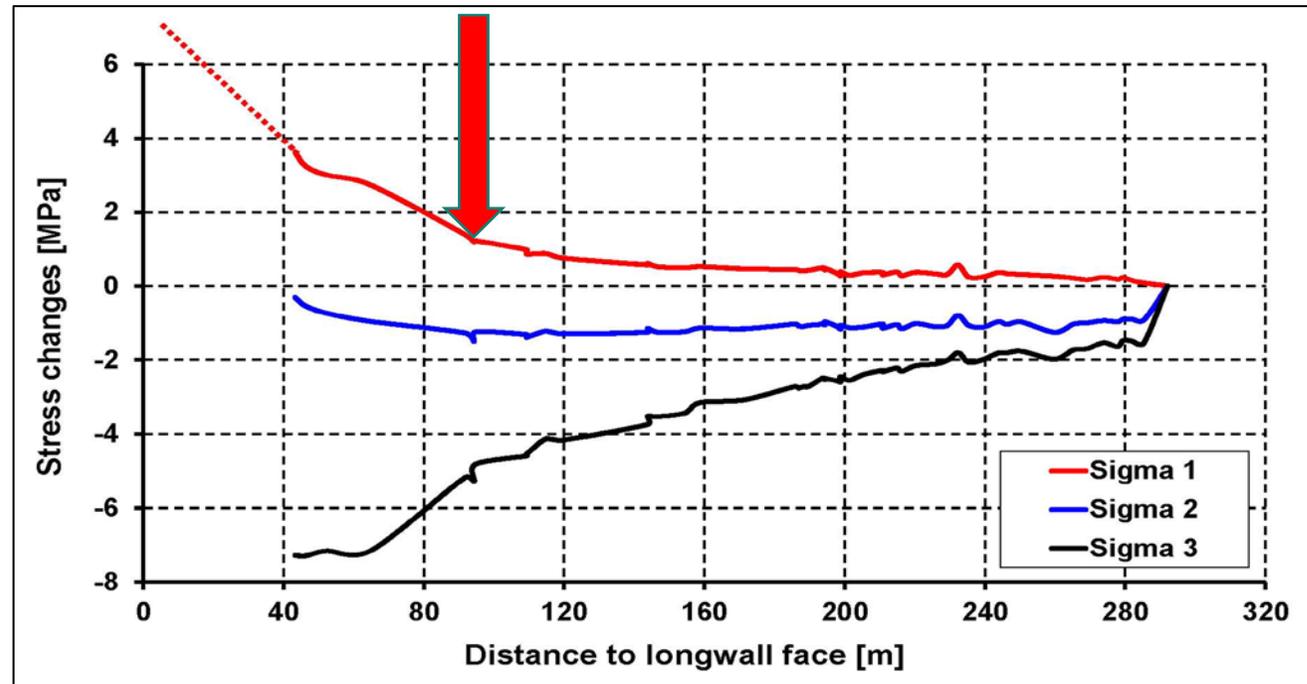
CCBM1

- Increase of significant stress changes started **90 m** ahead of the longwall face.
- The maximum stress component reached its maximum **3.7 MPa** at the distance 43 m from the longwall face. Unfortunately, the monitoring of this probe could not continue because the power supply cable was **damaged**. Repairs of the power supply cable were not allowed for mining safety reasons.

- Based on the evaluation of CCBM probe, the increase of significant stress changes started at the distance of **90 - 95 m** from the longwall face. The longwall II/501/C were equipped by power loader technology with seam thickness from **3.05 to 3.65 m**.

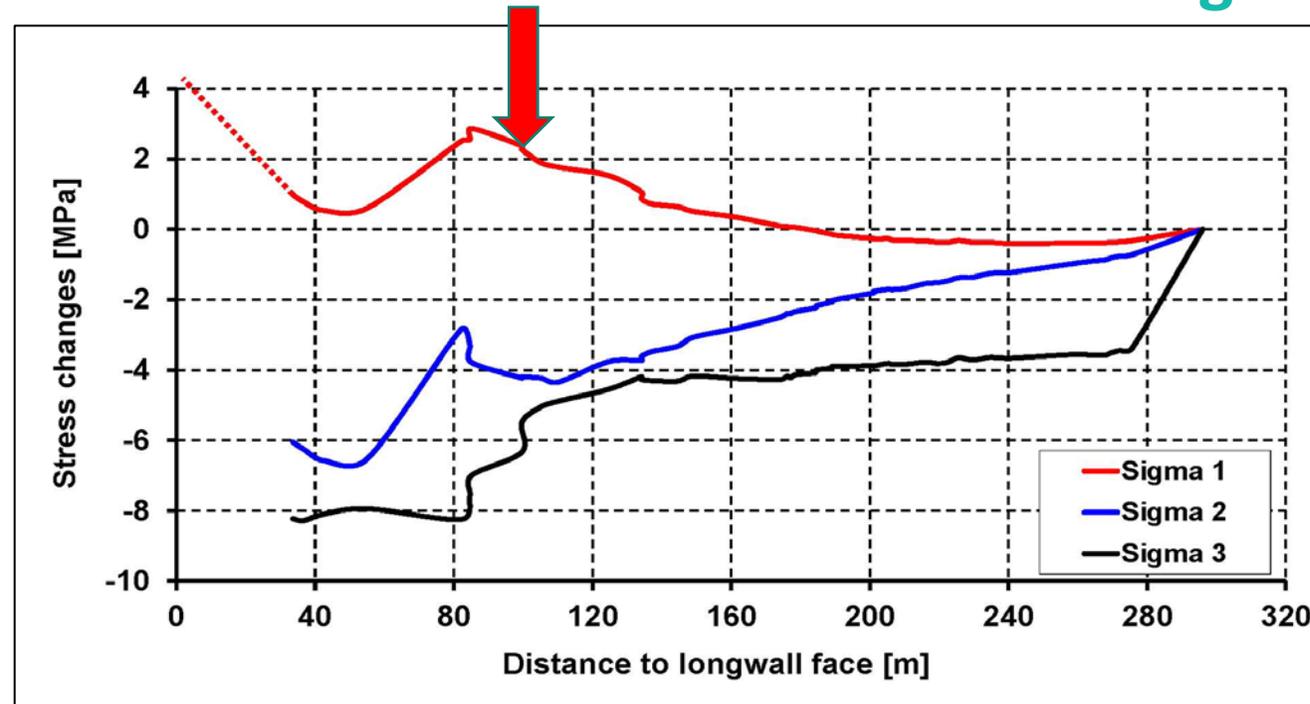
CCBM2

- Increase of significant changes in stress at a distance of approx. **95 m** from the front of the wall.
- The maximum stress component of Sigma 1 increased by **3 MPa** when 85 m ahead of the face.
- At the distance of approximately 85 m from the longwall face, there was a **rapid drop** in all stress components.

- Decrease of all stress components at the distance of approximately 85 m from the longwall face is related to the **stoppage of the longwall due to geological problems** experienced in the previous week.

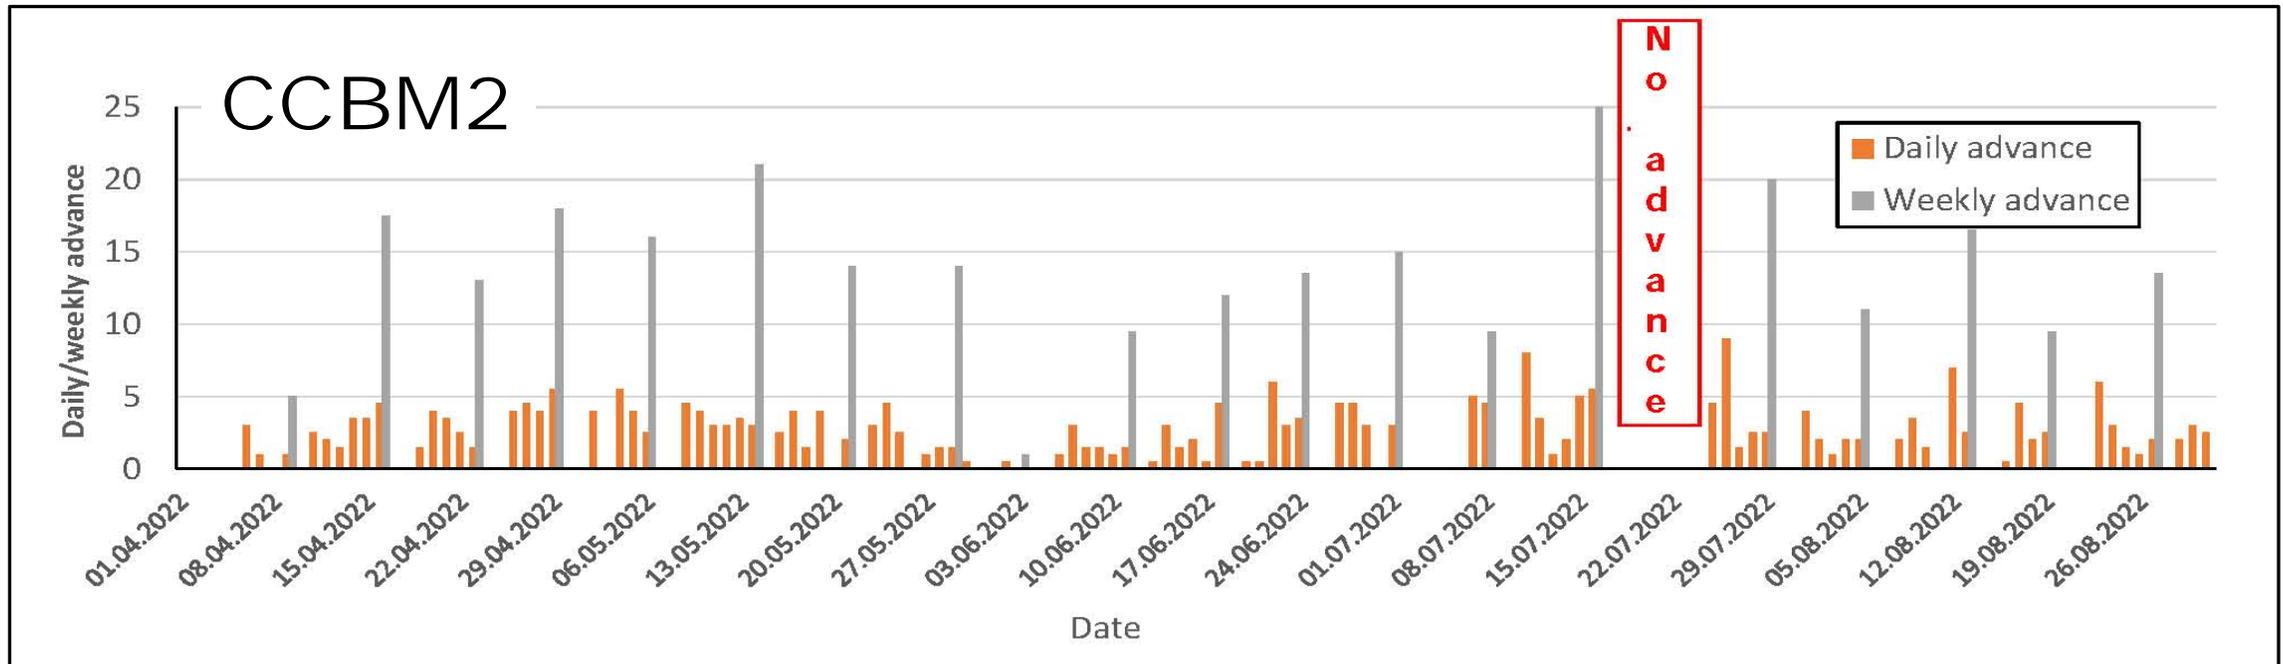
- This decrease is related to the **stoppage of the longwall** due to geological problems experienced in the previous week.
- The power supply cables of CCBM2 probe was also **damaged**, as in the case CCBM1 probe.
- The **CCBM3** probe **failed** due to technical damage in the initial monitoring stage.

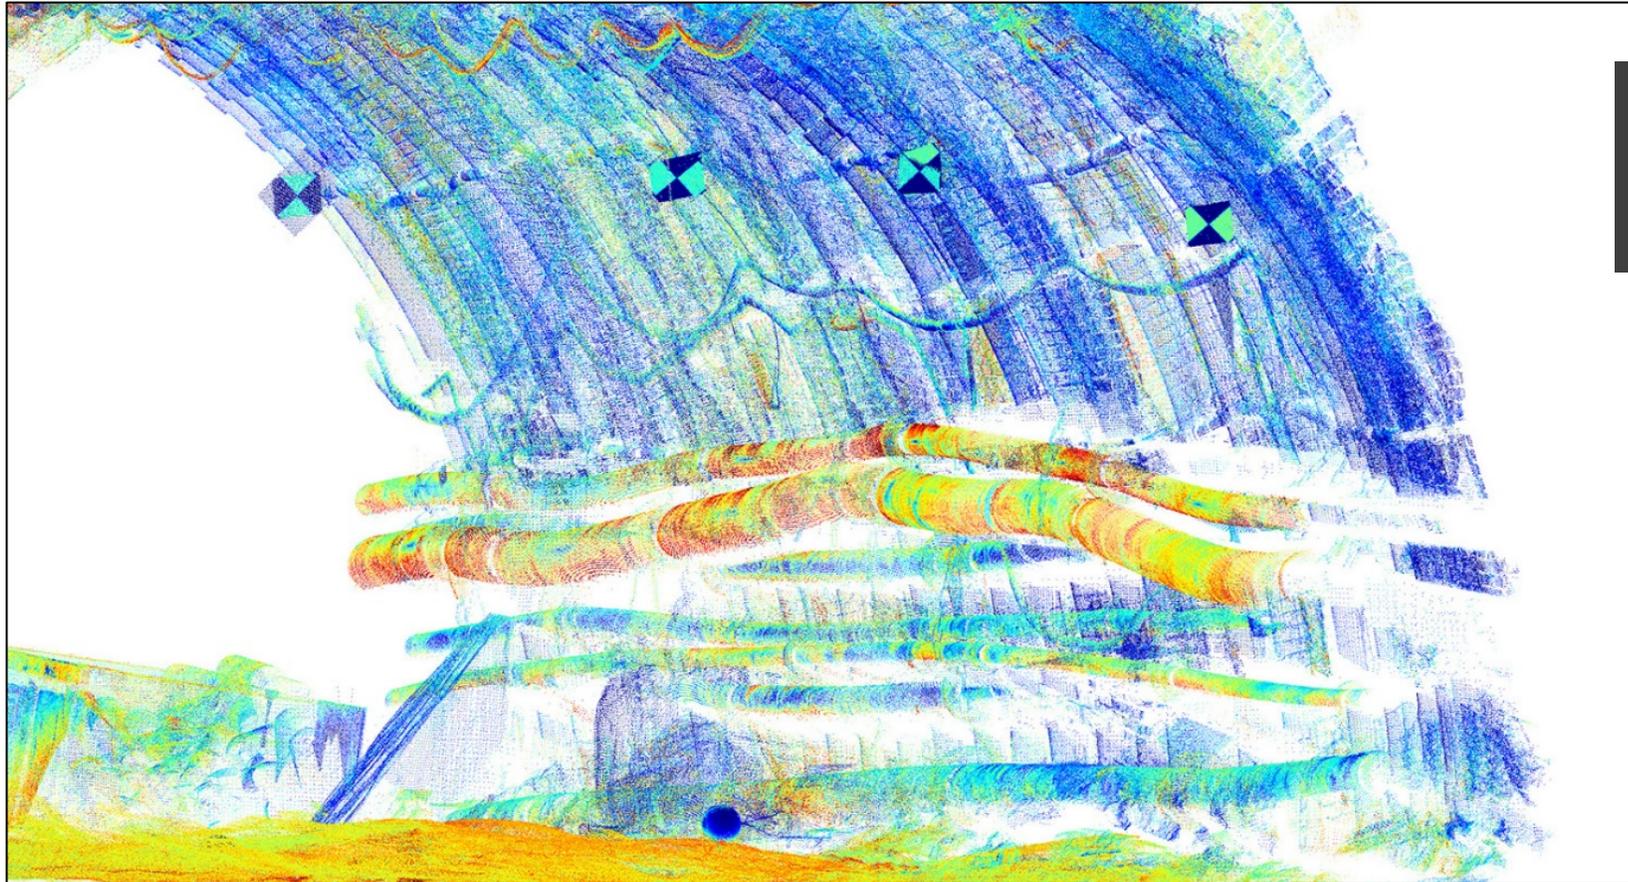
Checkerboard targets applied to align scans more accurately.

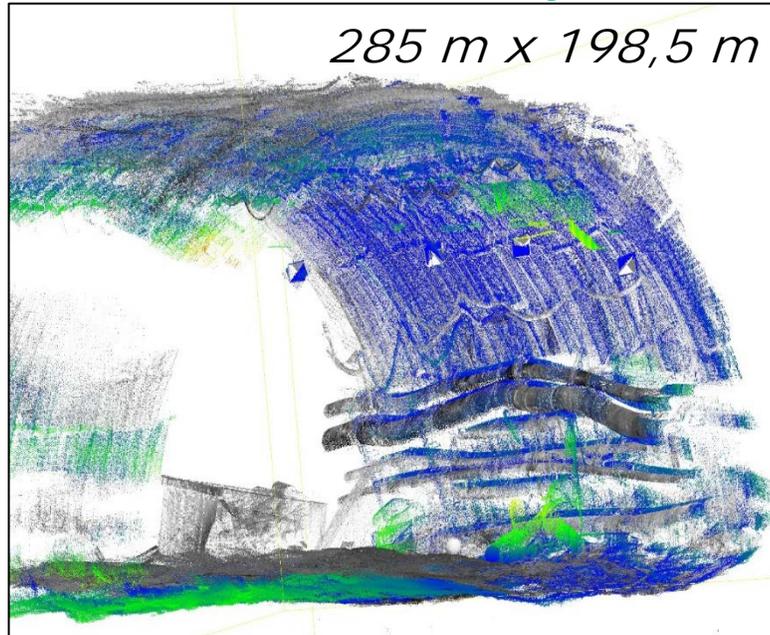
Changes only on the cable line
and on the pipeline.

The deformations of the steel arch reinforcement are not visible!!!

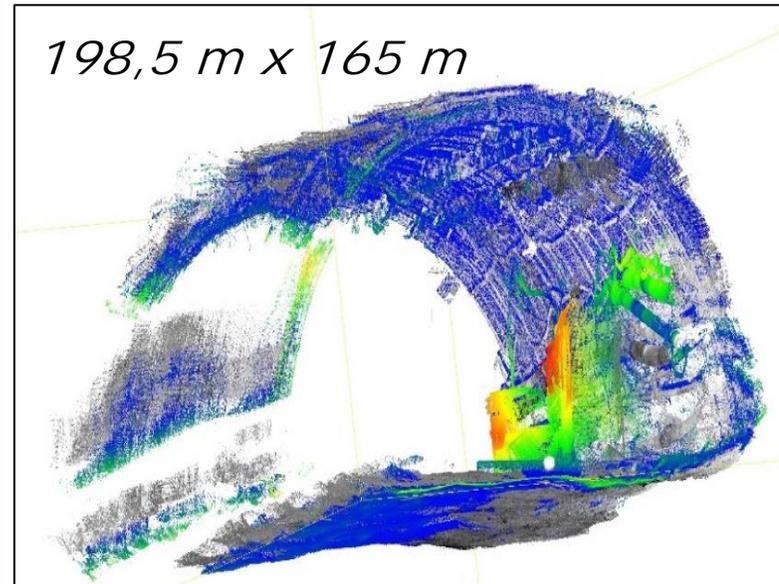
Changes only in the new
imported devices.

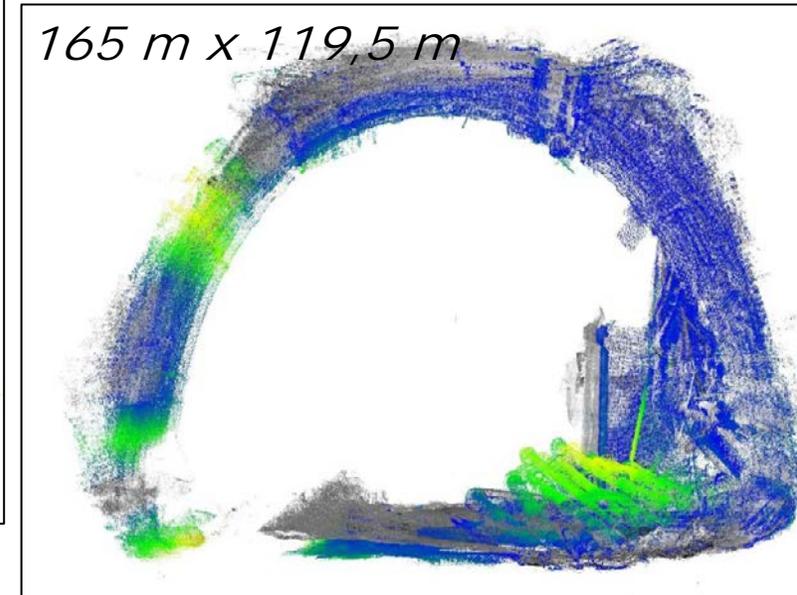
Changes only in the new
transported material.

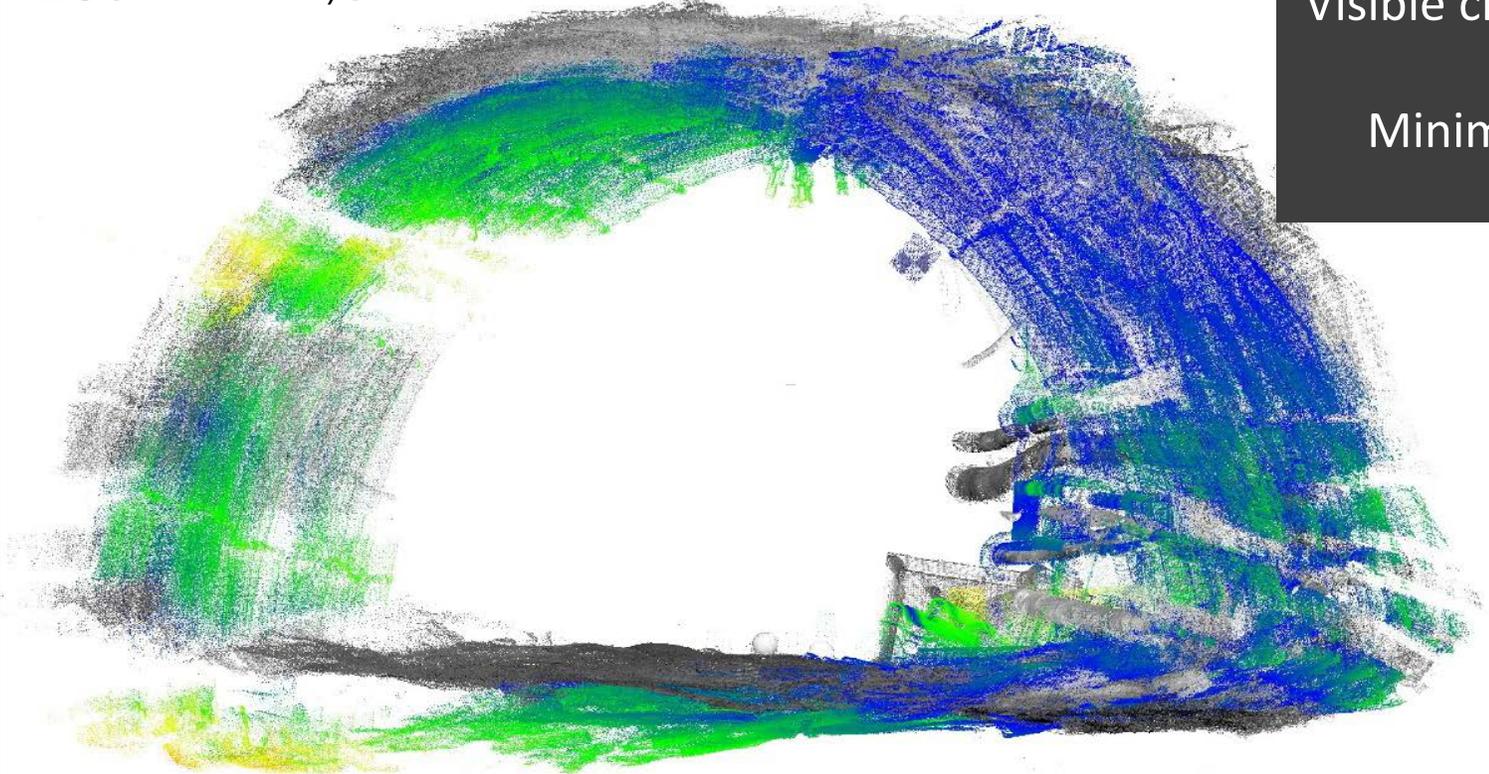
285 m x 91,5 m

Visible changes in the floor of roadway (~20cm).

Minimum deformation of ribside (0-12cm)

- Since the orientation of the maximum horizontal stress is **almost identical** to the orientation of the monitored roadway, **minimal deformations** of the roadway analysed on the basis 3D laser scanning were recorded.

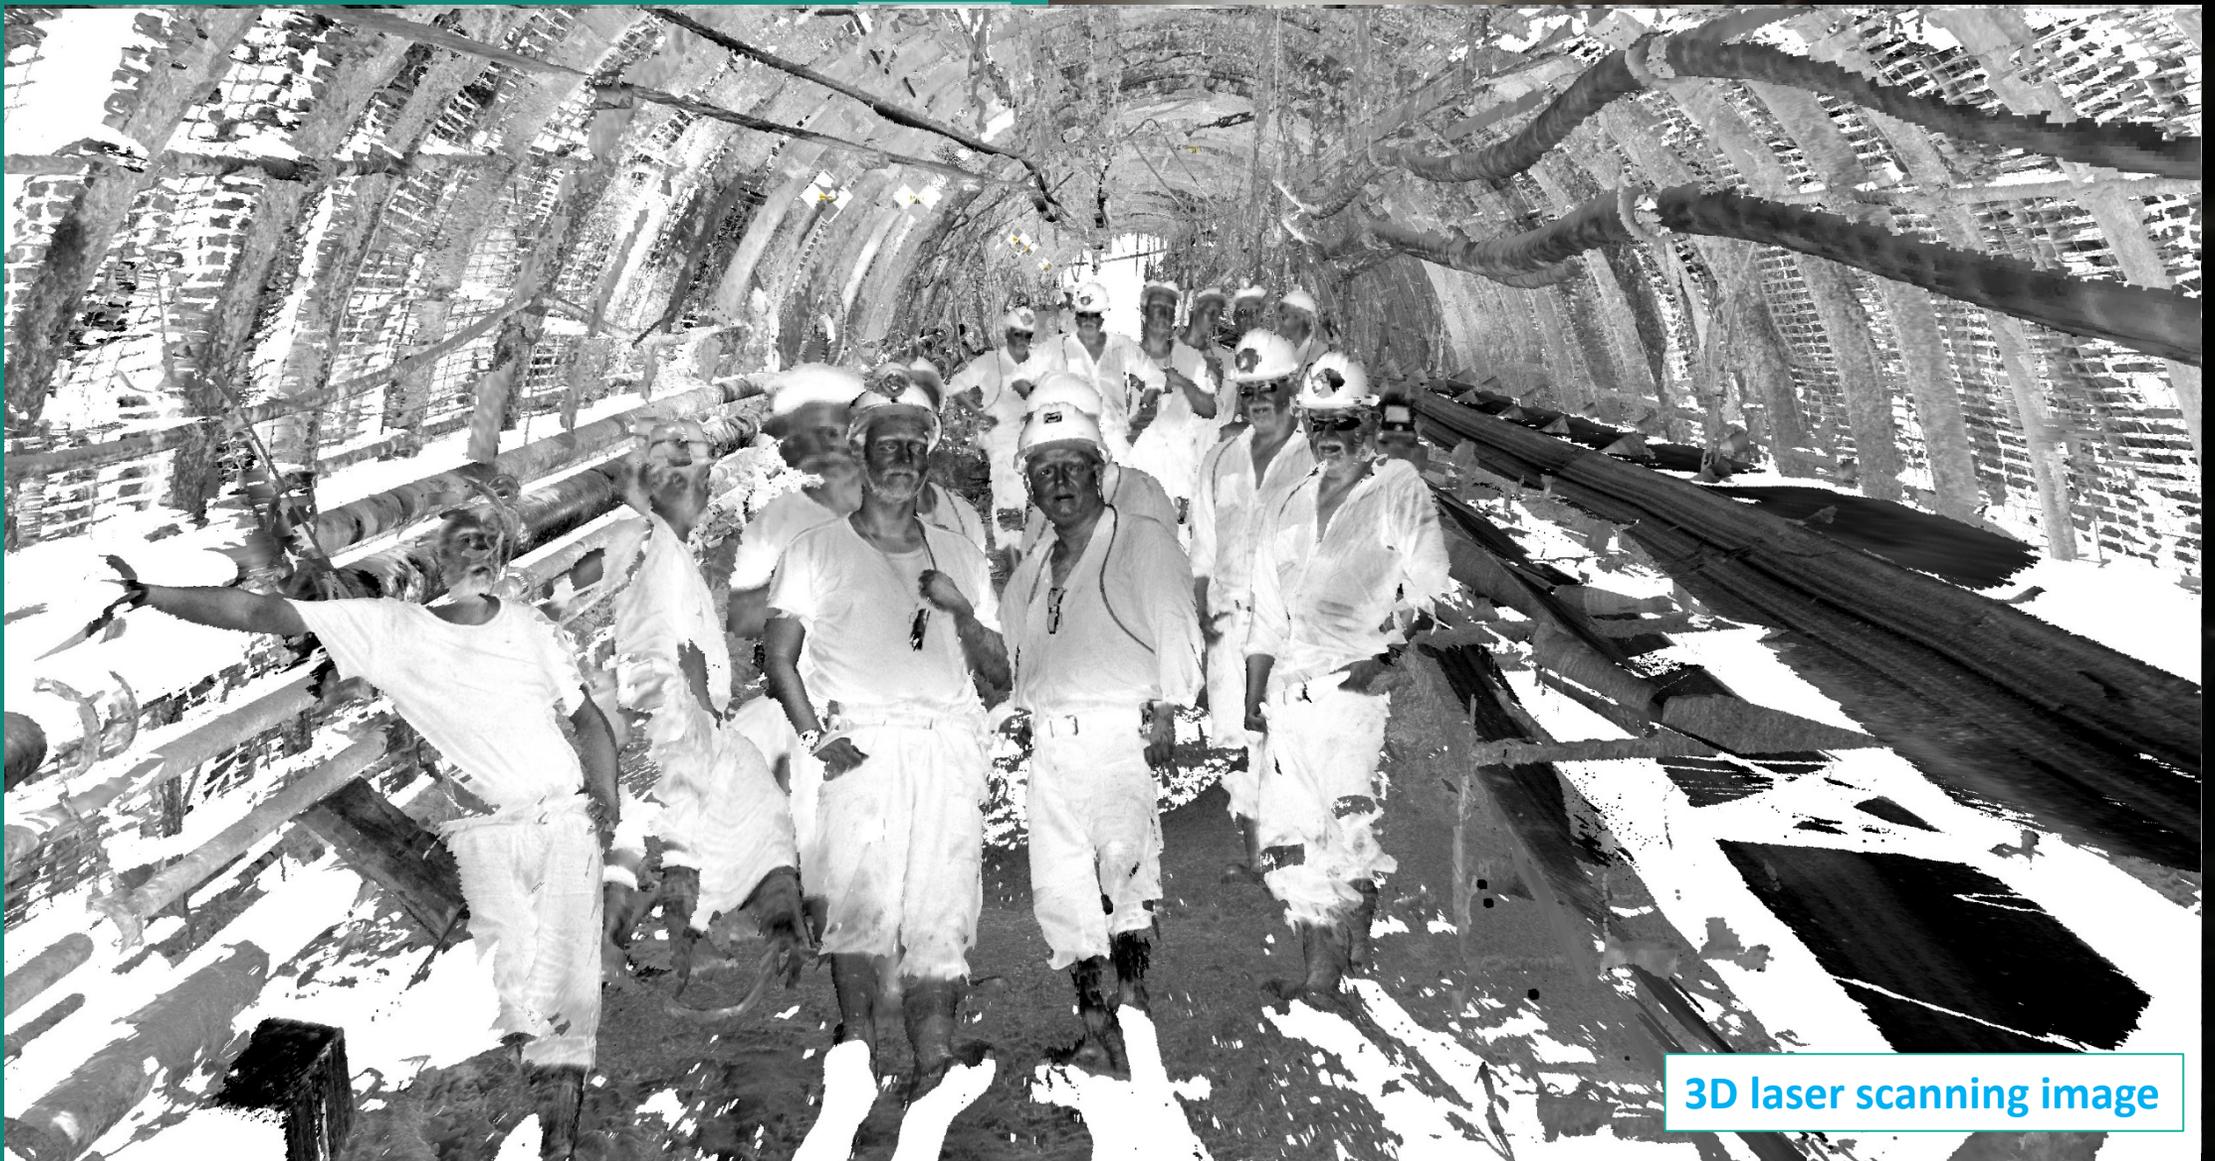
3D laser scanning image
