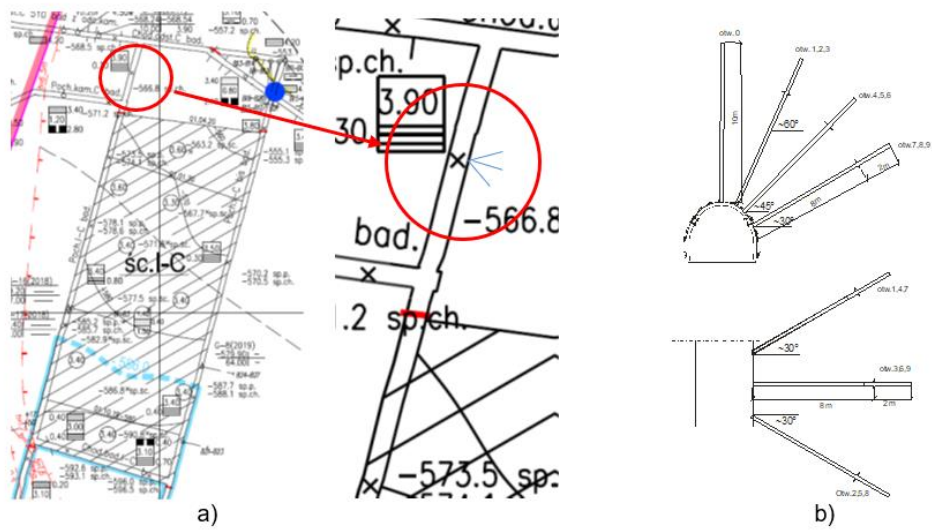
Site of the stress measurements (a) and boreholes to measure characteristic hydrofracturing pressures (b).

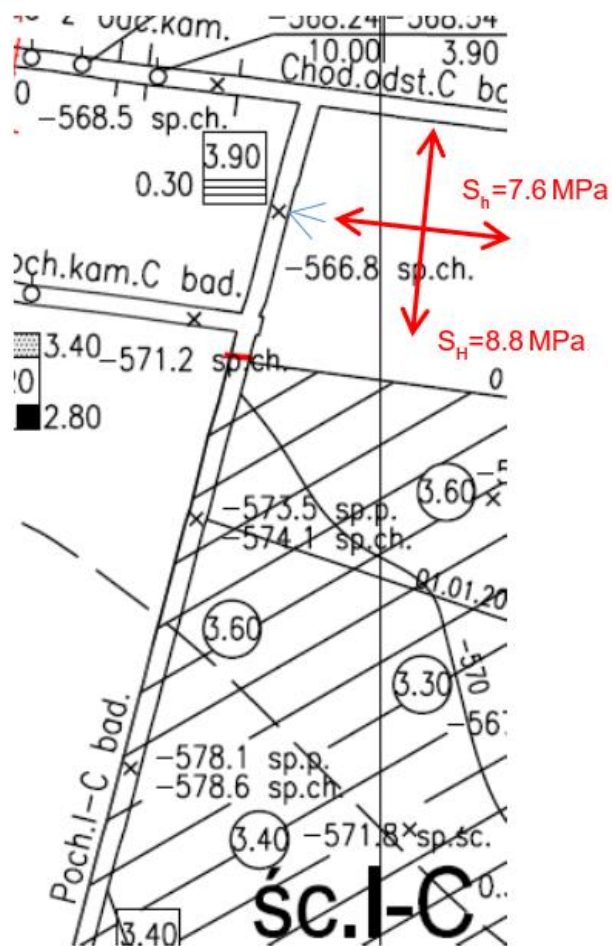
Directions and values of horizontal stresses obtained from measurements in gate 1-C in seam 501.
